Existing condition of the superstructure (girders)

Ranges from poor to fair

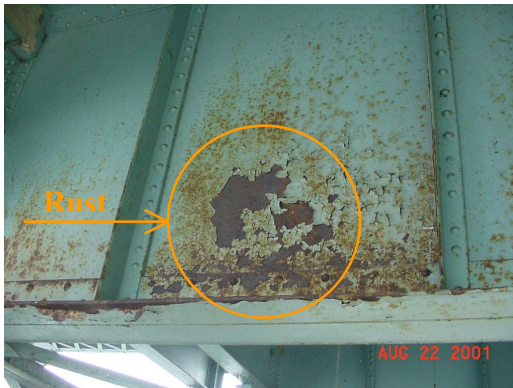
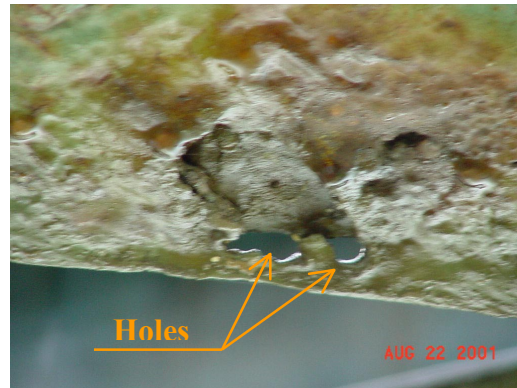
Corrosion of steel girders (from surface rust to holes) is a common problem with the Claude Allouez Bridge superstructure.

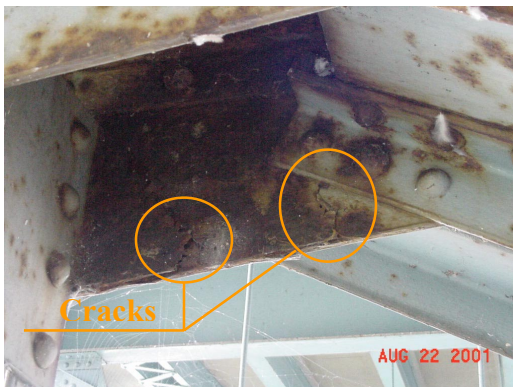
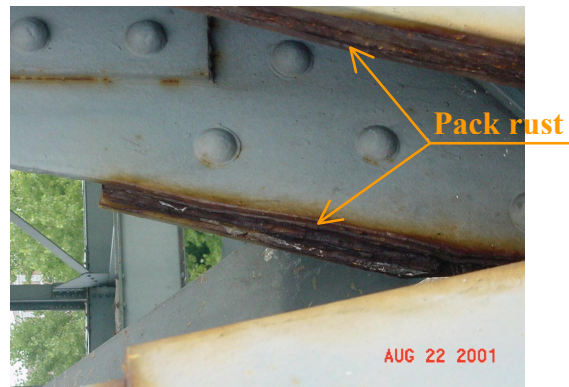
More examples of steel deterioration shown above include cracks in steel connection plates and pack rust between steel plates and girders.
